Please follow the procedure below should you encounter difficulties with the EU80 MINIETCH etching unit.

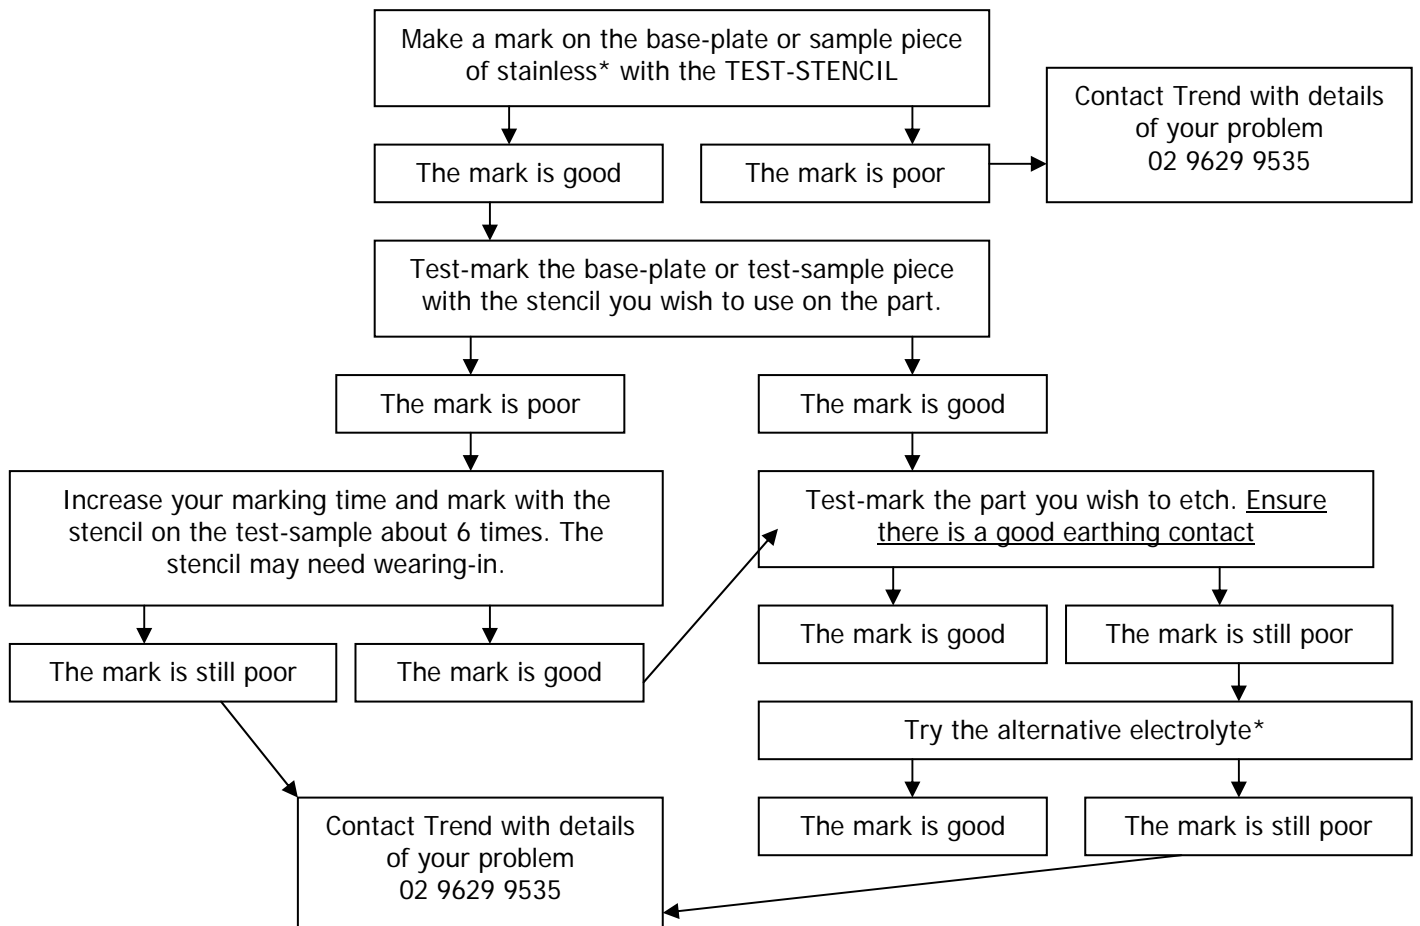
- ⊕ Select a PERMANENT TEST STENCIL*
- ⊕ Marking time should be approx. 2-3 seconds only.
- ⊕ Follow procedure below to make a comparison mark onto a stainless steel sample plate (or directly to the base-plate).
